DEPARTMENT OF TRANSPORTATION**DIVISION OF ENGINEERING SERVICES**

Contract #: 04-0120F4Cty: SF/ALA Rte: 80 PM: 13.2/13.9File #: 69.28**WELDING INSPECTION REPORT****Resident Engineer:**Pursell, Gary**Address:** 333 Burma Road**City:** Oakland, CA 94607**Report No:** WIR-014464**Date Inspected:** 28-May-2010**Project Name:** SAS Superstructure**OSM Arrival Time:** 700**Prime Contractor:** American Bridge/Fluor Enterprises, a JV**OSM Departure Time:** 1900**Contractor:** Zhenhua Port Machinery Company, Ltd (ZPMC), Changxing Island **Location:** Shanghai, China**CWI Name:** Mr.Huang Min**CWI Present:** Yes No**Inspected CWI report:** Yes No N/A**Rod Oven in Use:** Yes No N/A**Electrode to specification:** Yes No N/A**Weld Procedures Followed:** Yes No N/A**Qualified Welders:** Yes No N/A**Verified Joint Fit-up:** Yes No N/A**Approved Drawings:** Yes No N/A**Approved WPS:** Yes No N/A**Delayed / Cancelled:** Yes No N/A**Bridge No:** 34-0006**Component:** Orthotropic Box Girder(OBG)**Summary of Items Observed:**

This CALTRANS OSM Quality Assurance Inspector (QA) Surendra Prabhu was present during the times noted above for observations relative to the fabrication of the Self Anchored Sus

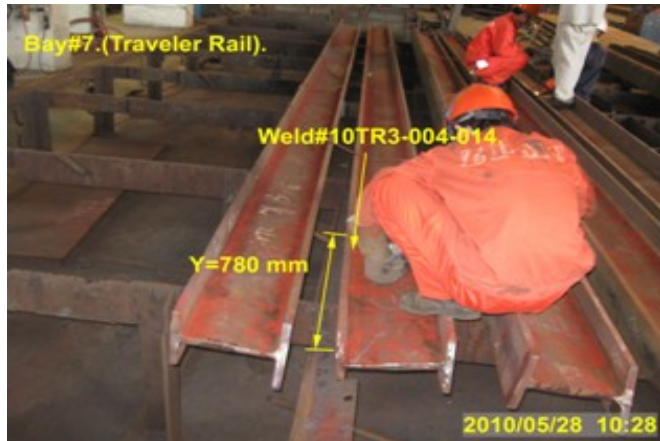
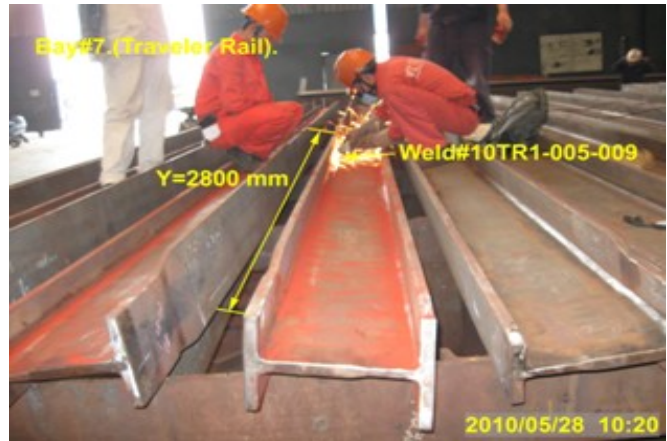
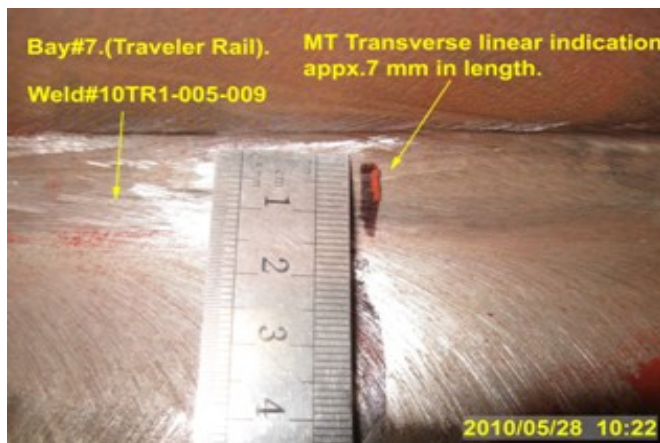
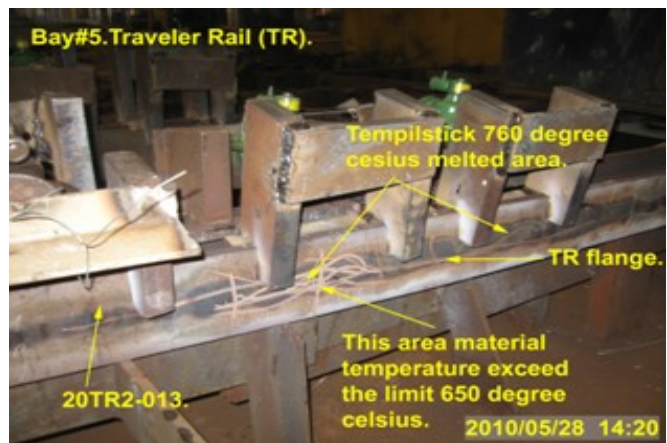
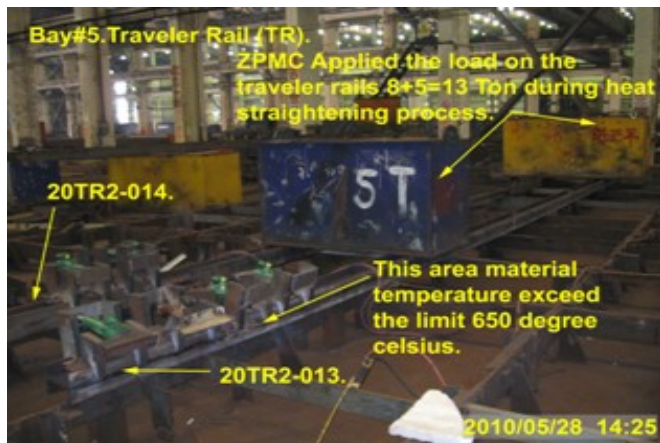
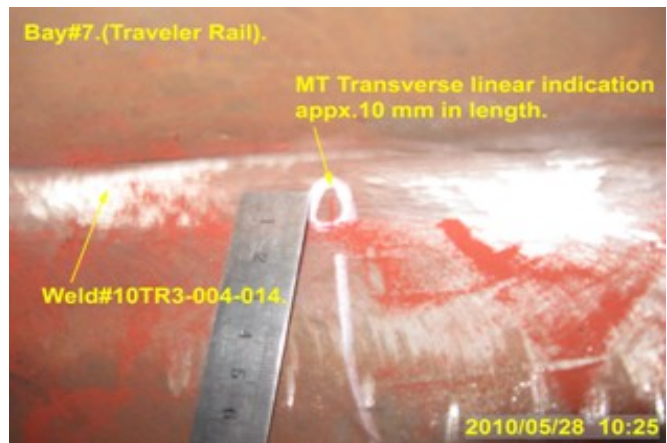
ZPMC personnel flame straightening traveler rail flange base plate. The material was heated to a bright red condition and the temperature is above 650°C. Per ZPMC Heat Straightening Report identified as HSR1 (B)-8350, the maximum allowable temperature is 650°C. The AWS D1.5 Section 3.7.3 states that the heated steel shall not exceed 650°C, which gives a dull red color. This QA Inspector observed the 760°C Tempilstik was melted when struck against the red base metal. A temperature indicating crayon, digital temperature measurement gauge, or other similar means of monitoring the temperature was not utilized by ZPMC QC and the actual maximum attained temperature was not measured. The Traveler rail is identified as 20TR2-013. Additionally, this QA Inspector observed ZPMC apply a 13 Ton load on the Traveler rail. ZPMC HSR1 Report doesn't specify the exact weight or weight range to be applied on the TR during heat straightening process.

ZPMC MT Technicians Mr.Tan Chao wei and Jin jian ting was performing Magnetic Particle Testing (MT) for the Traveler Rails (TR) identified as 10TR1-005 and 10TR3-004.This QA Inspector randomly witnessed the MT Inspection. During inspection above said ZPMC MT technicians were observed 2(Two) Transverse linear (crack) indications on weld number identified as 10TR1-005-009 and 10TR3-004-014.The indication length approximately measured to be 7 and 10 mm respectively. The “Y” locations approximately measured to be 2800 and 780 mm from the nearest end of the TR respectively.

This QA Inspector generated an incident report for the above issue on this date, for further information see the incident report and attached photograph.

As per ZPMC QC identified as Mr. Cui Jun Jie and American Bridge/Fluor (AB/F) QA Inspector identified as Mr. Chang they will take the approval from the Caltrans Engineer to perform the repair of these indications. The attached photos provide additional details.
